Manhole Inspection Summary

Manhole # S23AA1006MH

Location Address: **3633 BUENA VISTA AVE**

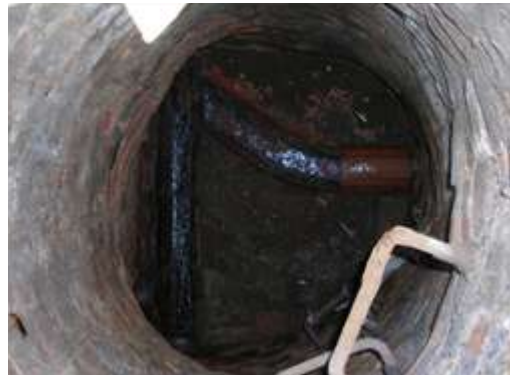
Top View

Corroded steps. Bench debris.

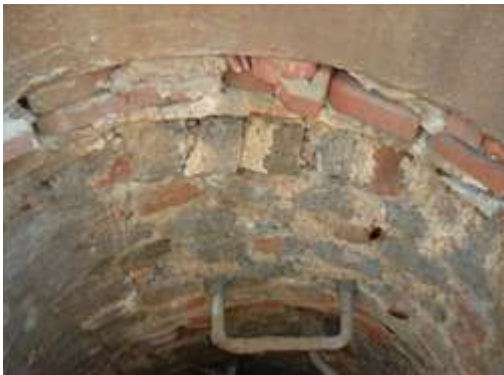
Defect

Frame leaks. Adjustment deterioration, loose brick and infiltration.

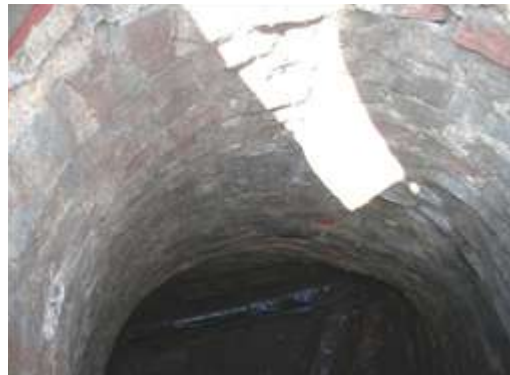
Defect

Adjustment, Corbel and Barrel infiltration - other side.

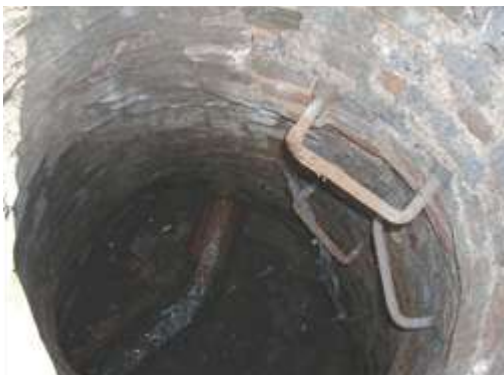
Defect

Adjustment, Corbel and Barrel infiltration.

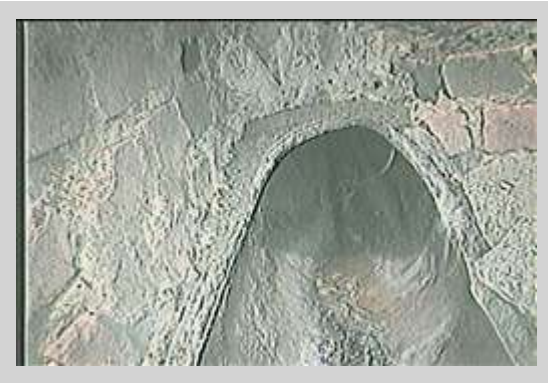
8 in. Circular Gravity Sewer Pipe Out @ 12 O'Clock

Barrel deterioration and infiltration.

Infiltration: **Evidence** Pipe Seal Cond: **Unknown**

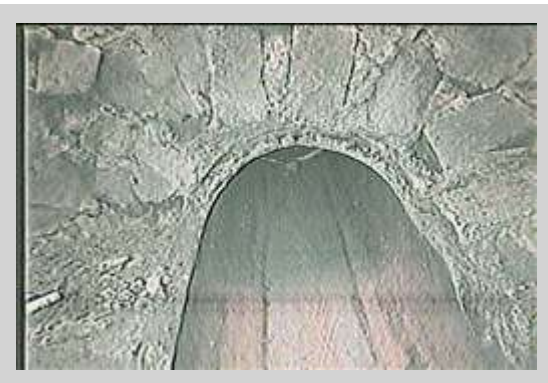
8 in. Circular Gravity Sewer Pipe In @ 3 O'Clock

Infiltration: **Evidence** Pipe Seal Cond: **Unknown**
